MINE LA MOTTE DAM

MADISON COUNTY, MISSOURI

MO 30289

**PHASE 1 INSPECTION REPORT
NATIONAL DAM SAFETY INSPECTION**

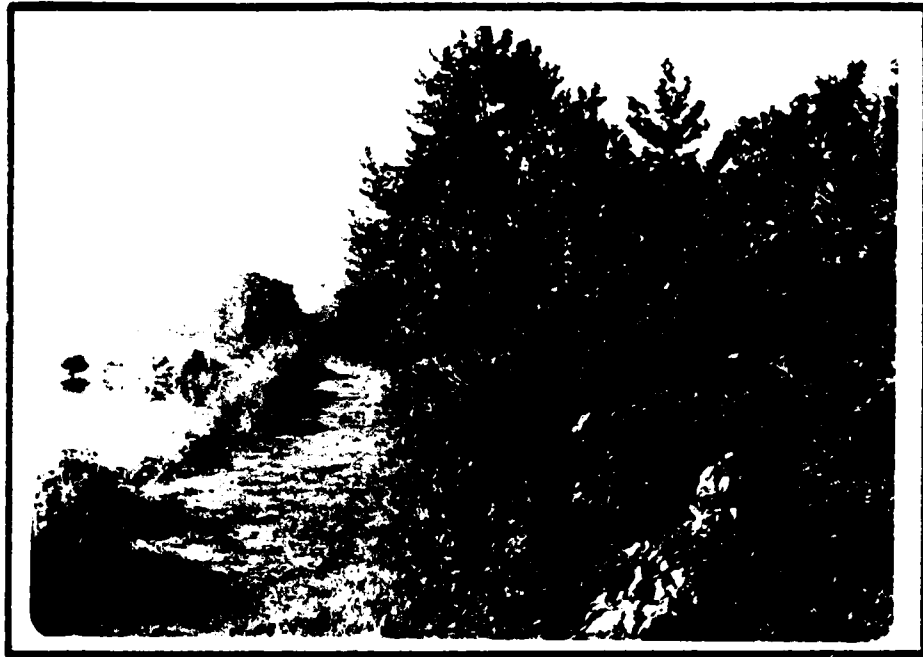
Photograph No. 2

Crest of dam looking toward left abutment.

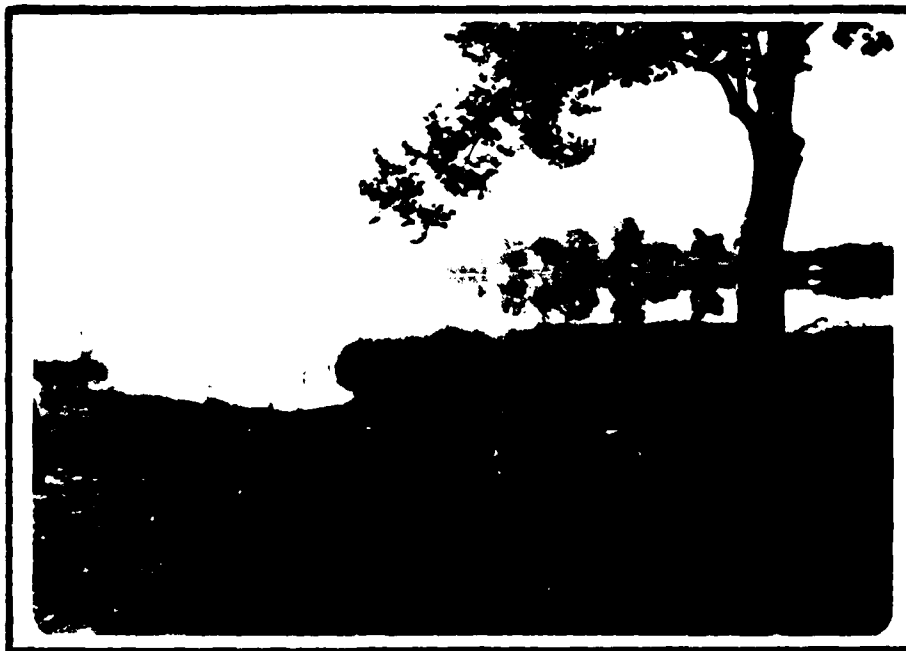
Photograph No. 4

Spillway control section.
